Brief Report of Visit to Sindhupalchowk District

27 April 2015

Mark Zimmerman, Stephen Knoble / Nick Simons Institute (NSI)

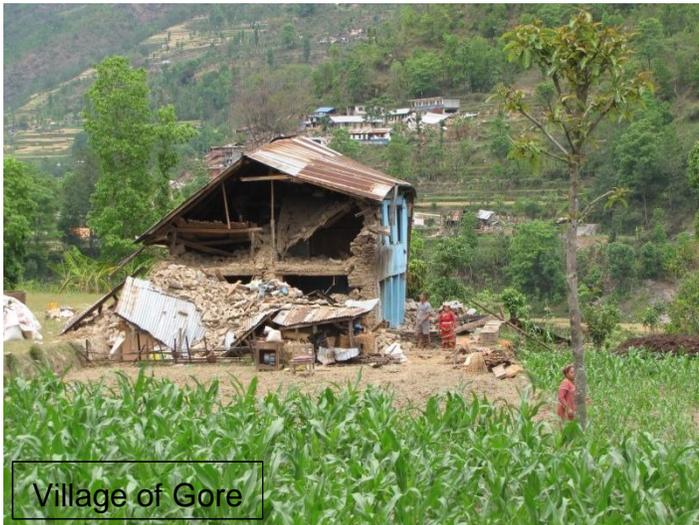
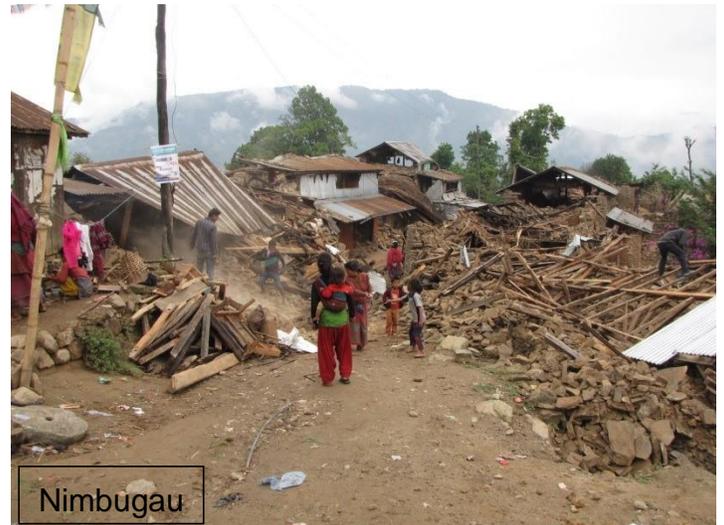
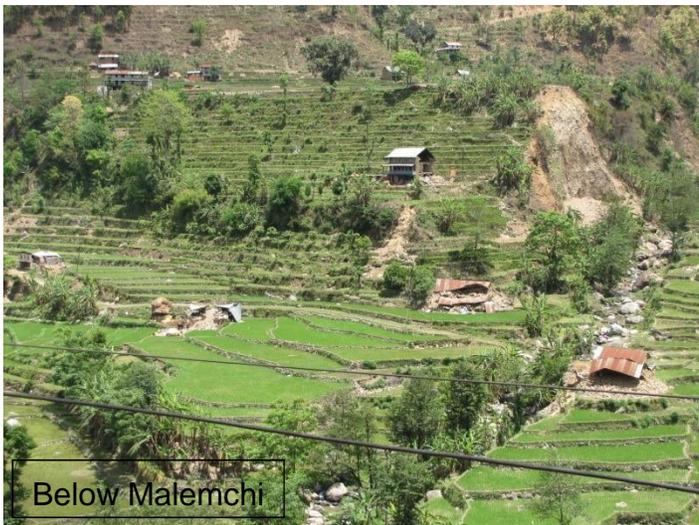
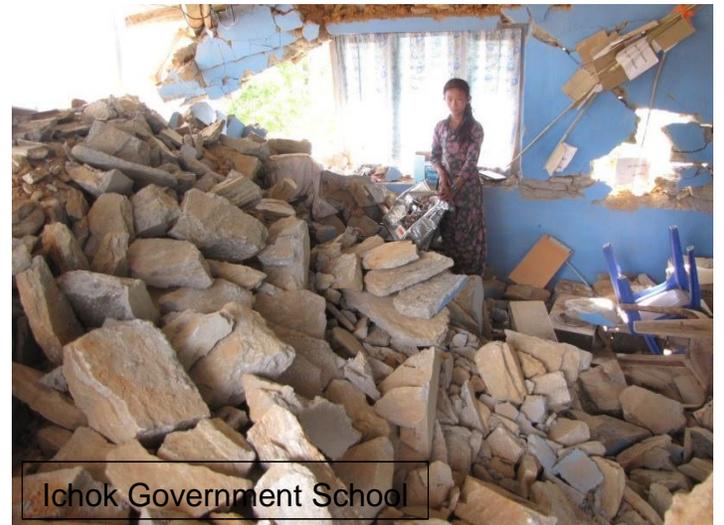
Images from Sindhupalchowk

- 80-90% of buildings have been rendered uninhabitable; 20-30% were razed to the ground. Pillared concrete buildings (accounting for less than 5% of the total) appeared to be intact. Almost no stone/brick/mortar buildings are now inhabitable.
- Many village roads, asphalt and cinder, have long cracks 3-6" wide. Only a few roads have craters large enough to prevent driving, but many are blocked by rock landslides. Sections of roadway will be pried away by the coming monsoon rains.
- Along our route, all bridges were intact with no overt signs of damage.
- Malemchi Primary Health Center (PHC), being a concrete building, is still intact. This is true of all police, army, drinking water, and other organizational buildings.

[NB These photos reflect this area's norm, rather than its extreme.]

4. Support for rebuilding of houses and farm structures

5. Rebuilding of roadways
